Preliminary Hand-Held Air Monitoring Locations | ITC Deer Park Tank Fire

Reading Date 3/27/2019 3:00:00 AM to 3/27/2019 5:00:00 AM

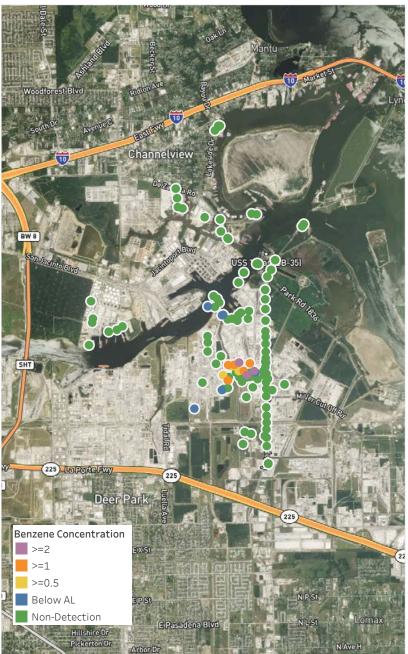
Recent Benzene Detections

Location Category	Reading Date	Concentration
Division B	3/27/2019 03:30:41	0.200 ppm
	3/27/2019 04:06:10	0.310 ppm
	3/27/2019 04:33:34	0.350 ppm
Division E	3/27/2019 03:04:16	2.400 ppm
	3/27/2019 04:04:56	1.100 ppm
	3/27/2019 03:33:23	2.000 ppm
	3/27/2019 04:08:37	0.425 ppm
	3/27/2019 03:17:03	1.275 ppm
	3/27/2019 03:37:04	0.525 ppm
	3/27/2019 04:12:56	0.350 ppm
	3/27/2019 03:21:14	0.875 ppm
	3/27/2019 04:00:10	0.540 ppm
	3/27/2019 04:46:15	0.625 ppm
	3/27/2019 04:40:48	0.825 ppm
	3/27/2019 04:47:08	1.080 ppm
	3/27/2019 04:56:12	1.200 ppm
	3/27/2019 04:52:47	1.325 ppm
Impacted Tank Farm	3/27/2019 04:03:38	0.360 ppm
	3/27/2019 04:22:07	2.850 ppm
Industrial Area	3/27/2019 03:00:25	1.250 ppm
	3/27/2019 03:25:23	0.180 ppm
	3/27/2019 03:18:13	1.975 ppm
